ArgoNeuT Status

Mitch Soderberg

9/23/2008

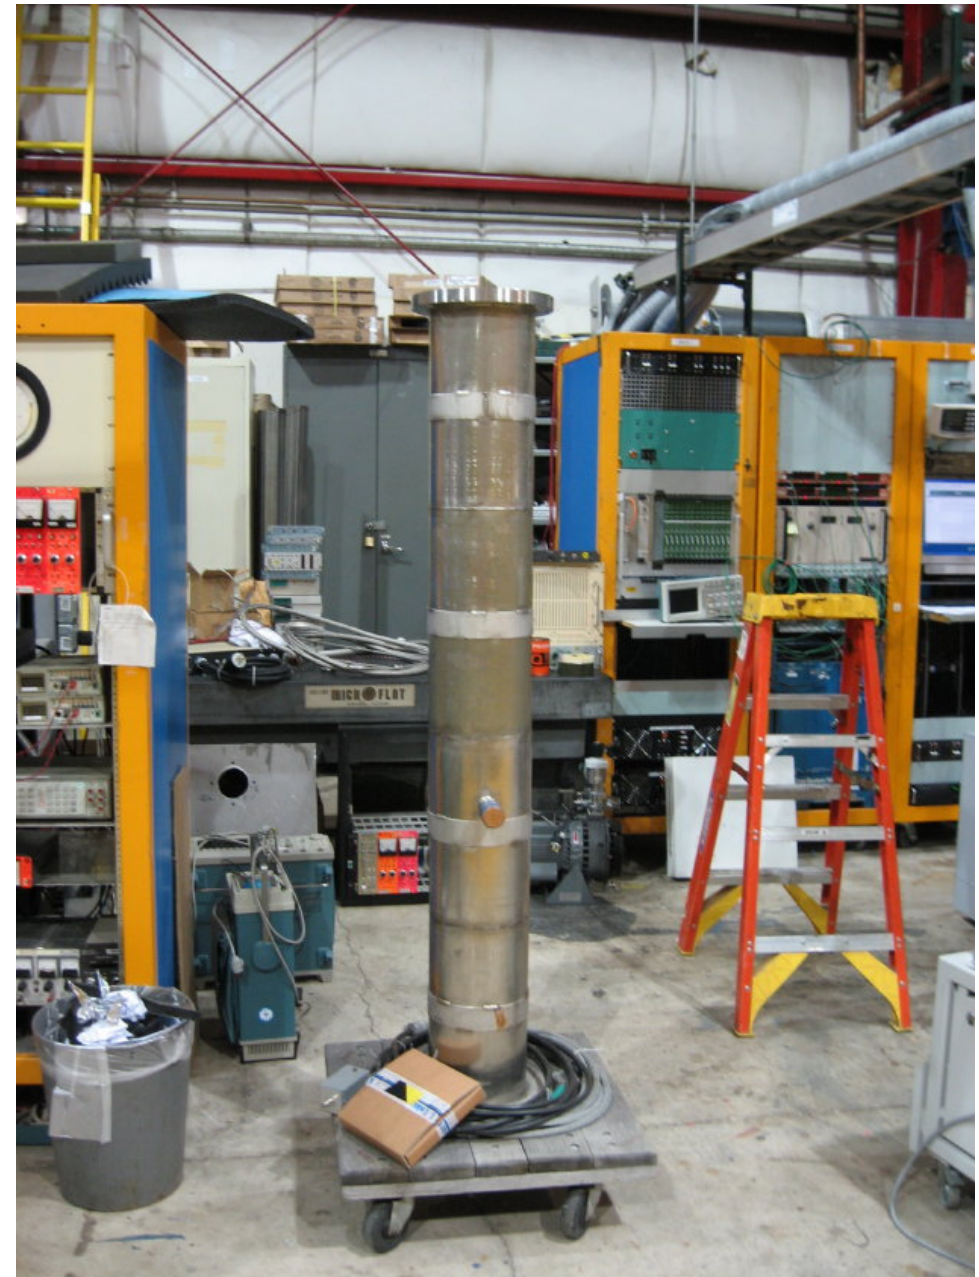
HV Test

- Hans has offered to let us use this vacuum jacketed dewar to test our HV feedthrough.
- Install feedthrough on top flange, then fill until end of feedthrough is submerged.
- Ramp HV slowly up to 25kV....see if current drain is detected or not.
- If current drain is detected, feedthrough needs to be replaced.
